**AIRCRAFT GROUND-FLOTATION INVESTIGATION**  
**PART II. DATA REPORT ON TEST SECTION I**

*U. S. ARMY ENGINEER WATERWAYS EXPERIMENT STATION*

TECHNICAL REPORT AFFDL-TR-66-43, PART II

APRIL 1966

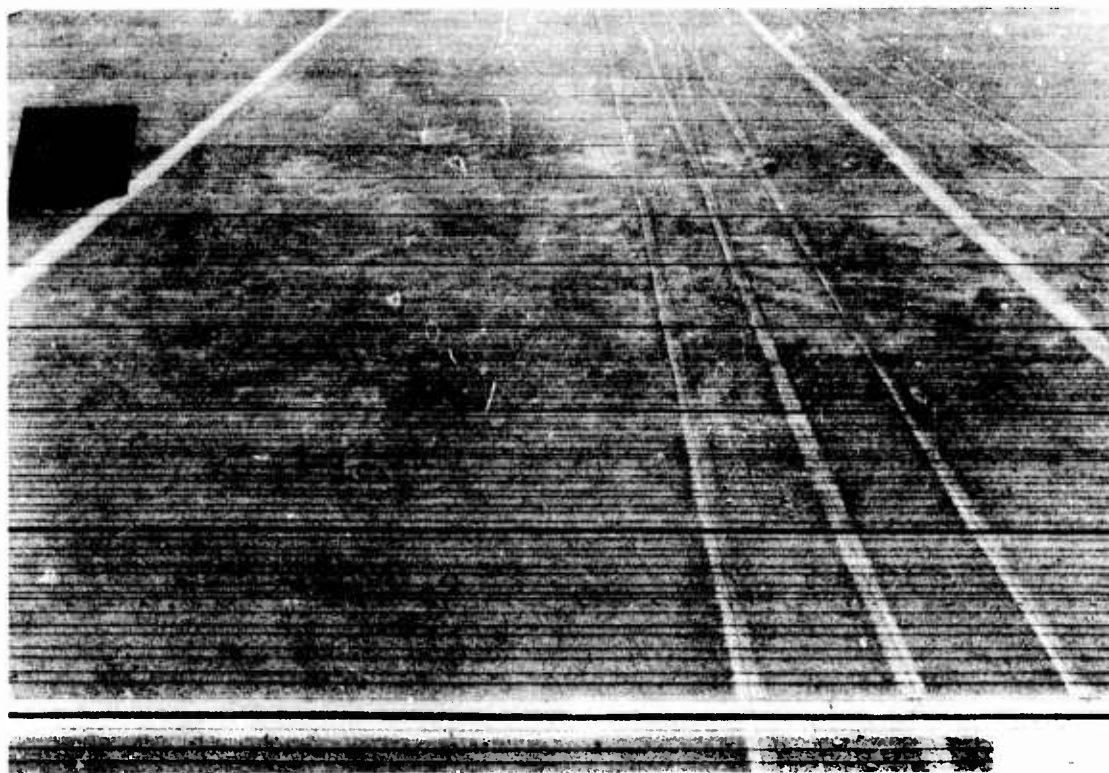
Item 2. The average subgrade CBR was 15 for the top 12 in. of soil in item 2 prior to traffic. Slight rutting of the surface resulted from two passes of the load vehicle during 0-coverage drawbar pull tests. After 20 coverages, the entire item had depressed in the tracked lane approximately 1 in. and the surface was relatively flat and in very good condition ( **Figure 3** ). A reduced rate of soil depression continued throughout the traffic period. At 40 coverages, the average CBR had increased to 34 for the top 12 in. of soil. Slight rutting of the surface was evident when traffic was suspended at 300 coverages, but the overall condition of the item remained good ( **Figure 4** ) and it was not considered failed. The traffic was discontinued because the CBR was increasing with traffic, and an excessive amount of time would have been required to develop a failure. The rated CBR of the item was 27 after 300 coverages of the test vehicle.

Figure 4. Lane 1, item 2, at 300 coverages  
(traffic suspended, no failure)

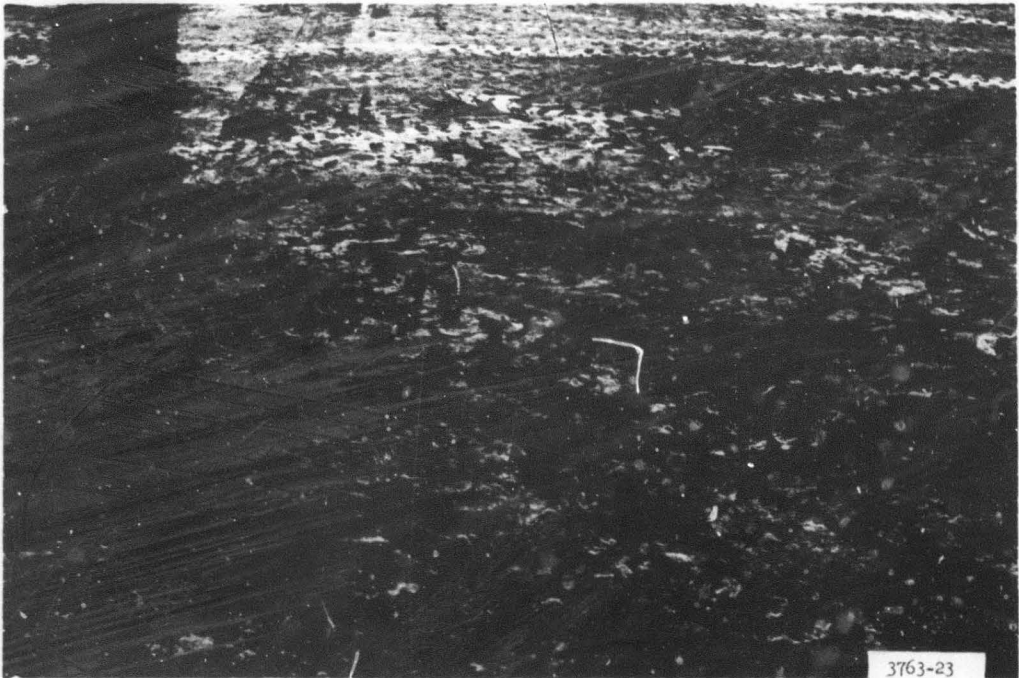
Item 3. Item 3 prior to traffic is shown in **Figure 5**. After 20 coverages, there were slight differential mat deformations along with an initial soil depression of about 1 in. No significant mat damage was evident with continued traffic to 100 coverages. At 135 coverages, sheared rivets and increasing differential deformations were noted. At 200 coverages, cracks appeared in the mat surface, but the item remained in serviceable condition. Traffic was continued to 300 coverages, at which time the mat was considered failed due to excessive roughness and mat deterioration ( **Figures 6 and 7** ). The rated CBR for the item was 7.4.

**Figure 7.** Lane 1, item 3, at 300 coverages (failure).  
Longitudinal straightedge shows deformation

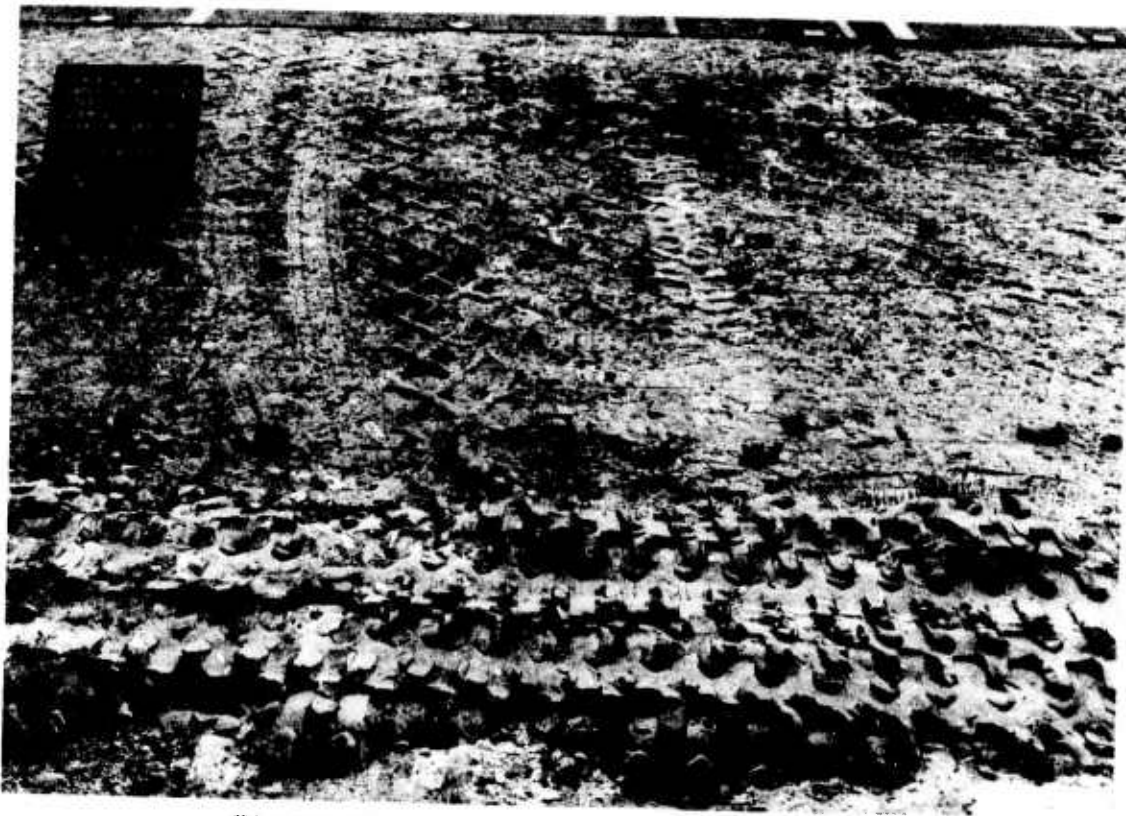
Item 1. Item 1 prior to traffic is shown in **Figure 8.** The average subgrade CBR for the top 12 in. of soil in item 1 was 10 prior to traffic. The test vehicle caused severe rutting after two passes were made in an attempt to record 0-coverage drawbar pull values. Rut depths exceeded 4 in., and the item was judged failed at two passes **Figure 9.**

**Figure 9.** Lane 2, item 1, at two passes (failure)

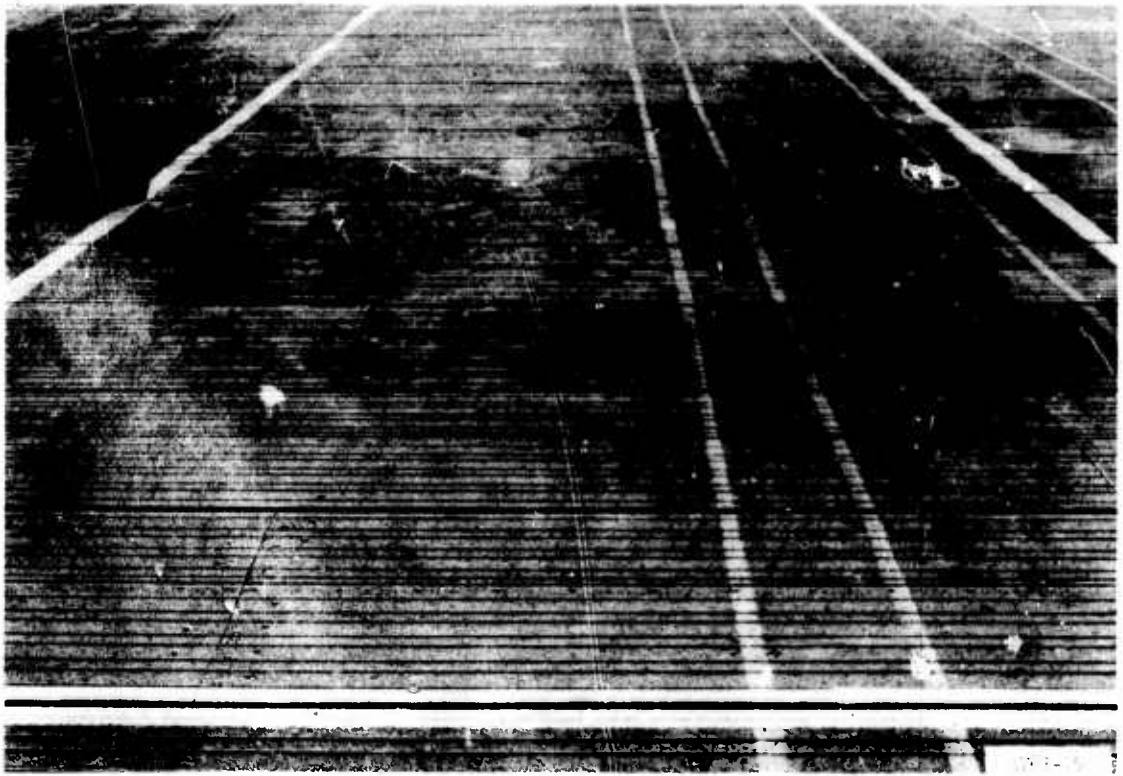
Item 2. Item 2 prior to traffic is shown in **Figure 10.** Except at the transition between item 2 and the previously failed item 1, the item showed no severe distress prior to 100 coverages, but it deteriorated rapidly thereafter. At 130 coverages the item was considered failed due to roughness and shear deformation in the soil (**Figure 11**). A slight increase in CBR (from 15 CBR to 22 CBR) occurred with trafficking. The rated CBR of the item was 18.

Figure 11. Lane 2, item 2, at 130 coverages (failure)

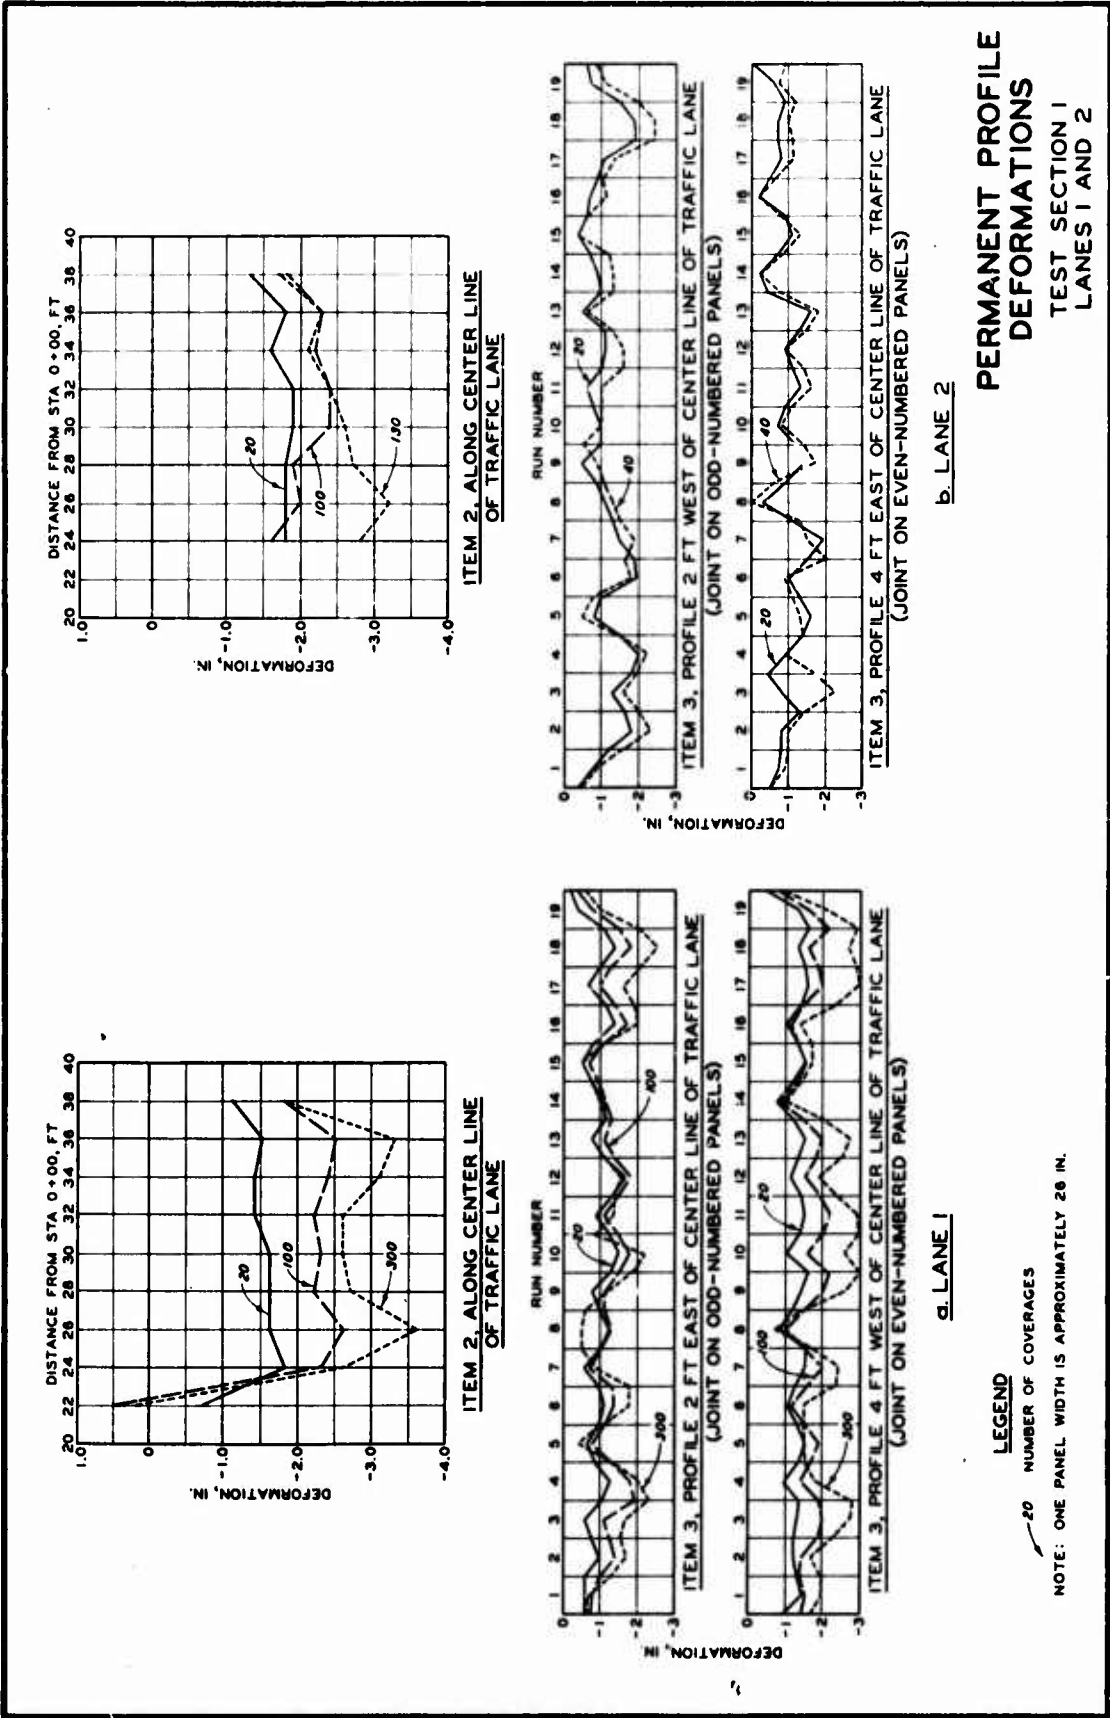
Figure 21

Item 1. No uniform traffic coverage was possible on item 1, as failure due to severe rutting occurred during preliminary passes made for drawbar pull measurements. The values recorded for drawbar pull are shown in table 1. A cross-section plot showing average soil deformation at failure is shown in **Figure 21**.

- b. Deformation. Average soil deformation increased uniformly during trafficking. A maximum average deformation of 3.3 in. was measured at 300 coverages when traffic was suspended. **Figs 21 and 22** show average cross-section and profile surface deformations at various coverage levels.

- b. Deformation. Mat deformations are shown in **Fig 21**. The mat cross section progressively assumed a trough shape as trafficking proceeded, reaching a maximum deformation of 2.8 in. Development of longitudinal deformation is indicated in **Fig 22**. The maximum deformation measured along this direction was 3.0 in.

- a. Roughness. At failure, the maximum transverse and diagonal differential deformations (table 1) were 3.38 and 3.13 in., respectively.
- b. Deformation. Average cross section and profile deformation plots are shown in **Figures 21 & 22**, respectively. A maximum average cross-section deformation of 3.5 in. was measured at failure. Along the center-line profile, maximum average deformation was 3.2 in. Rutting in item 2 was more pronounced on the south end adjoining the previously failed item 1 due to progression of ruts from the transition.

- b. Deformation. Average cross-section deformation plots are shown in **Fig 21**. A maximum deformation of 2.0 in. was measured at failure. A profile deformation plot is shown in **Figure 22**.
